## Historic Brewery Tower

5 April 2016

# Tumwater Brewery Seismic Retrofit Plan

# Tumwater Brewery Brew House Renovation North Elevation

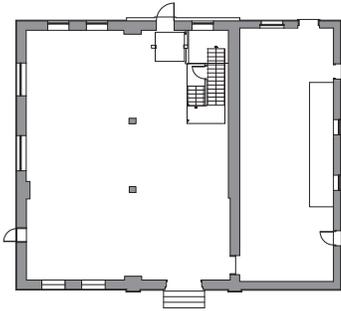
BASE SCOPE PLANS:

1ST FLOOR PLAN: Approx. 715 ft<sup>2</sup> open

2ND FLOOR PLAN Approx. 400 ft<sup>2</sup> open

3RD FLOOR PLAN: Approx. 225 ft<sup>2</sup> open

4TH FLOOR PLAN Approx. 535 ft<sup>2</sup> open

5TH FLOOR PLAN: Approx. 455 ft<sup>2</sup> open

6TH FLOOR PLAN Approx. 155 ft<sup>2</sup> open

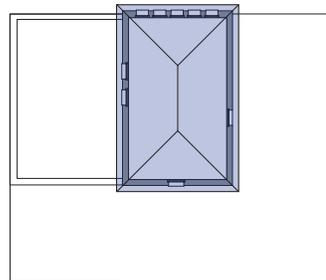
ROOF PLAN

Roof Area: 560 ft<sup>2</sup>

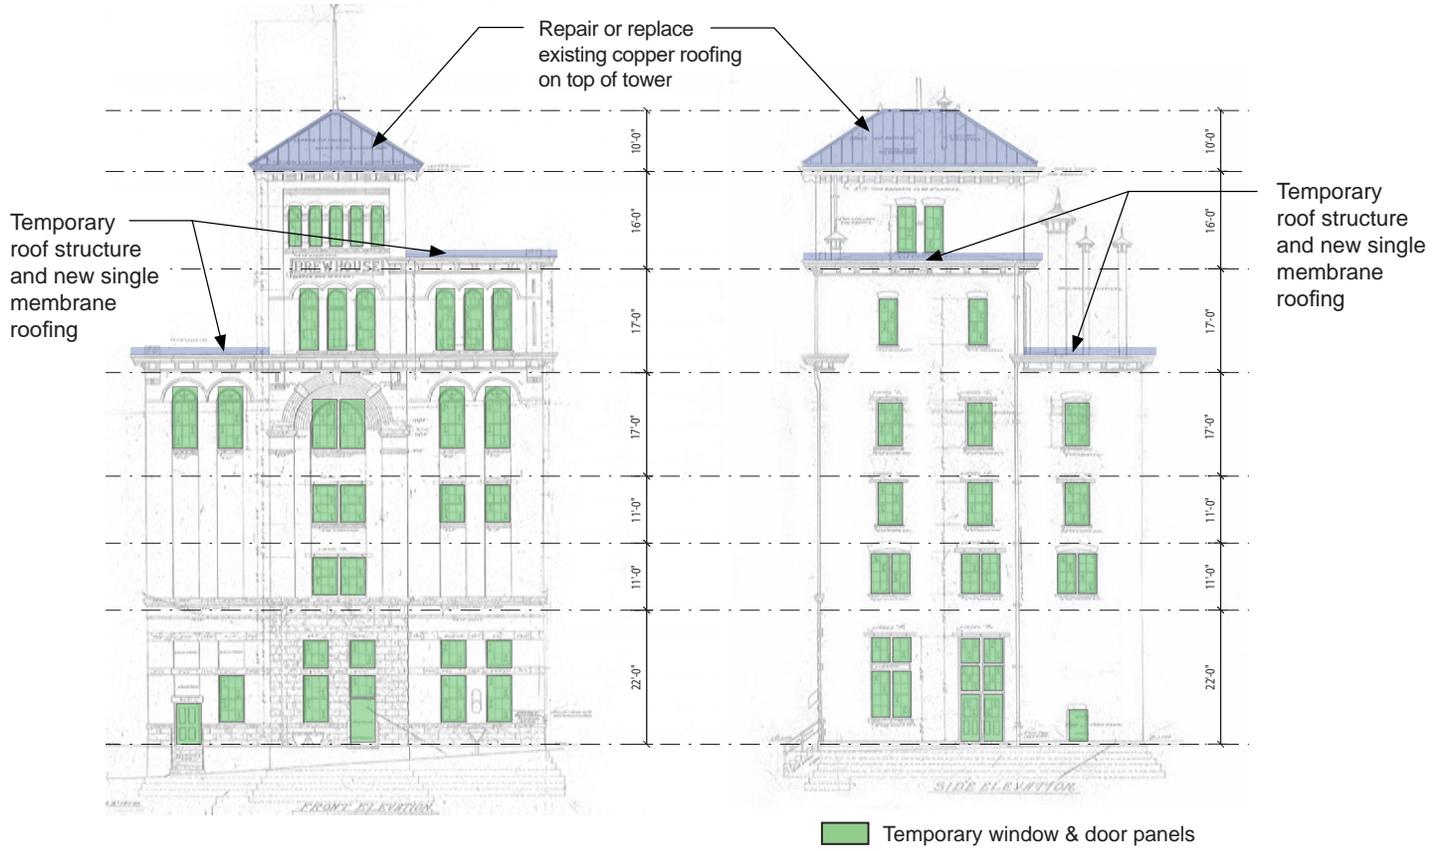
BASE SCOPE ELEVATIONS:

1. Temporary roof structure and new single membrane roofing. This would include new wood framing for the roof structure, new plywood sheathing, new coverboard, & new membrane.
2. Repair or replace existing copper roofing on top of tower.
3. Temporary window & door panels constructed of painted marine-grade plywood panels. These would be installed behind existing window & door frames and painted dark gray.

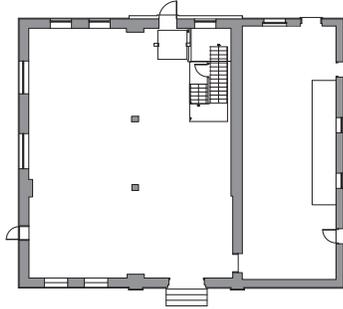
ADDITIVE SCOPE PLANS:

1ST FLOOR PLAN: Approx. 715 ft<sup>2</sup> open

2ND FLOOR PLAN Approx. 400 ft<sup>2</sup> open

3RD FLOOR PLAN: Approx. 225 ft<sup>2</sup> open

4TH FLOOR PLAN Approx. 535 ft<sup>2</sup> open

5TH FLOOR PLAN: Approx. 455 ft<sup>2</sup> open

6TH FLOOR PLAN Approx. 155 ft<sup>2</sup> open

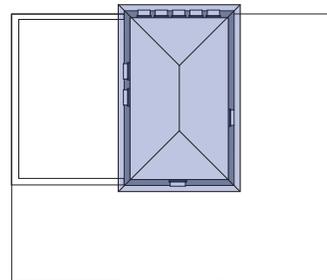
ROOF PLAN

Roof Area: 560 ft<sup>2</sup>

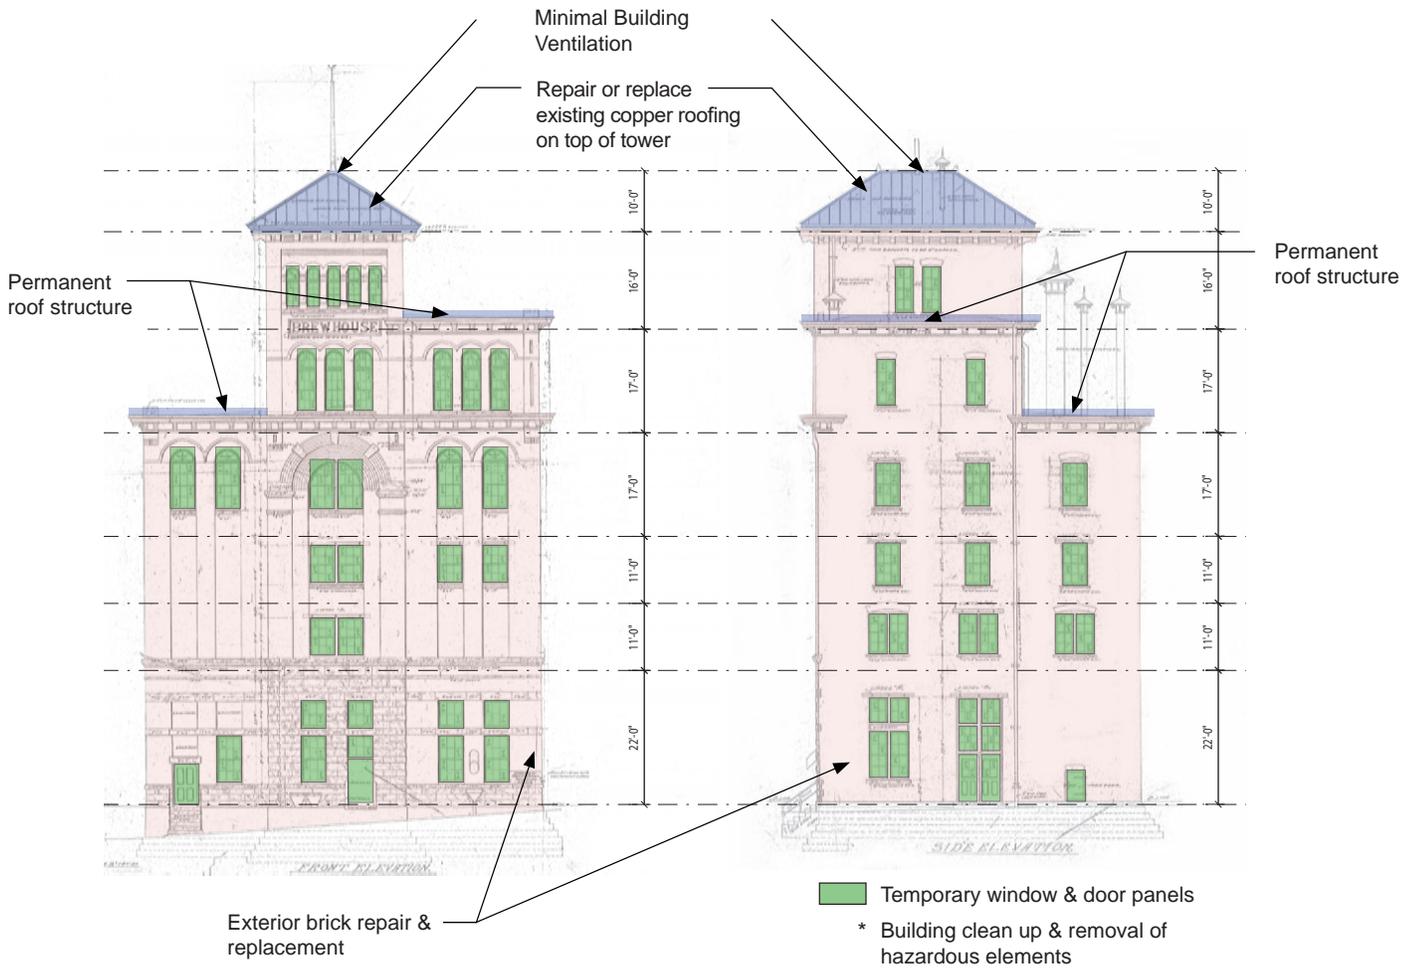
ADDITIVE SCOPE ELEVATIONS:

1. Exterior brick repair & replacement following historic preservation process and review.
2. Permanent roof structure following historic preservation process and review.
3. Permanent modified bitumen torch-down roofing following historic preservation process and review.
4. Minimal building ventilation including roof-mounted powered attic fans and low air intake (if necessary), to mitigate mold, mildew & rust.
5. Building cleanup & removal of hazardous elements.

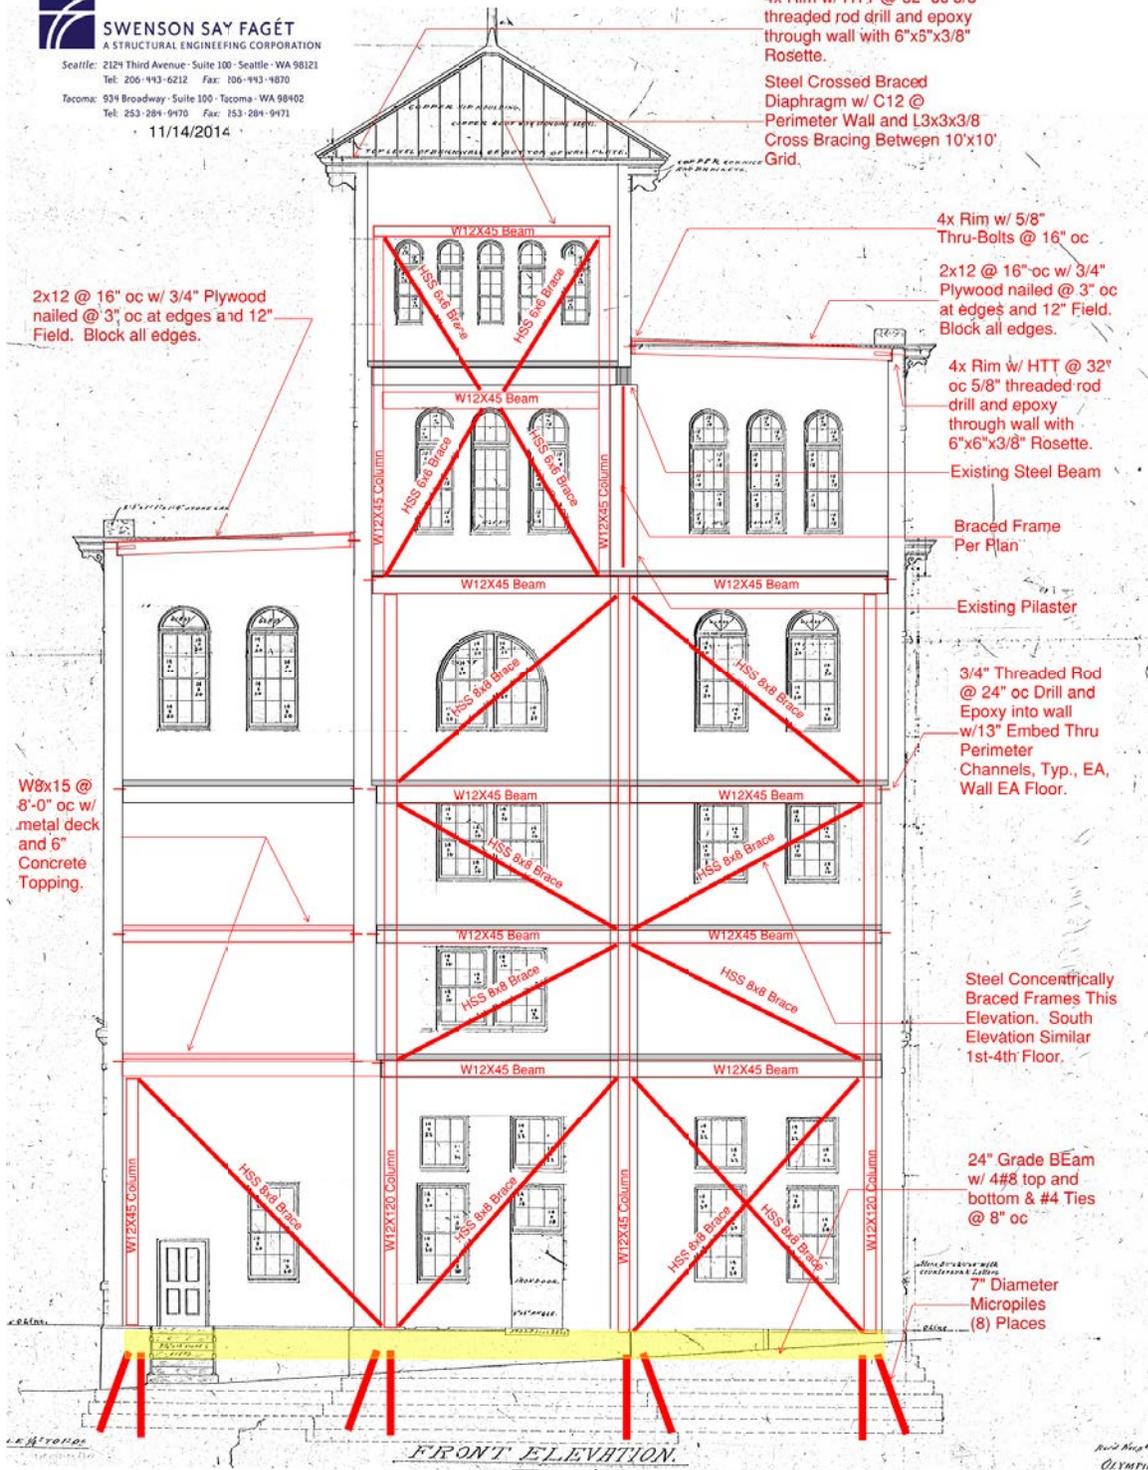
FRONT ELEVATION.

South  
Elevation  
Similar

2x12 @ 16" oc w/ 3/4" Plywood  
nailed @ 3" oc at edges and 12"  
Field. Block all edges.

W8x15 @  
8'-0" oc w/  
metal deck  
and 6"  
Concrete  
Topping.

4x Rim w/ HTT @ 32" oc 5/8"  
threaded rod drill and epoxy  
through wall with 6"x5"x3/8"  
Rosette.

Steel Cross Braced  
Diaphragm w/ C12 @  
Perimeter Wall and L3x3x3/8  
Cross Bracing Between 10'x10'  
Grid.

4x Rim w/ 5/8"  
Thru-Bolts @ 16" oc

2x12 @ 16" oc w/ 3/4"  
Plywood nailed @ 3" oc  
at edges and 12" Field.  
Block all edges.

4x Rim w/ HTT @ 32"  
oc 5/8" threaded rod  
drill and epoxy  
through wall with  
6"x6"x3/8" Rosette.

Existing Steel Beam

Braced Frame  
Per Plan

Existing Pilaster

3/4" Threaded Rod  
@ 24" oc Drill and  
Epoxy into wall  
w/13" Embed Thru  
Perimeter  
Channels, Typ., EA,  
Wall EA Floor.

Steel Concentrically  
Braced Frames This  
Elevation. South  
Elevation Similar  
1st-4th Floor.

24" Grade BEam  
w/ 4#8 top and  
bottom & #4 Ties  
@ 8" oc

7" Diameter  
Micropiles  
(8) Places

Following is a summary of findings and retrofit recommendations based on our ASCE 41-13 evaluation of the Brewhouse building. Please see the schematic seismic retrofit plan and building elevations at the end of this report for a more detailed description of the recommended retrofit measures. Implied but not explicitly described or detailed is the need for restoration of the existing masonry walls including replacement of damaged or missing brick and repair and repointing of the masonry mortar joints. This work should be completed in conjunction with the recommended work outlined below.
